Environmental Survey Report

Project Name: WCIND Phillippi Creek Dredge Feasibility	CC Project Number: 137100
Date of Survey: June 11, 12, and 17, 2024	Date of Report: August 30, 2024
Prepared By: Rebecah Delp & Alex Pacelko Cummins Cederberg, Inc.	Prepared For: West Coast Inland Navigation District Attn: Justin D. McBride, Executive Director

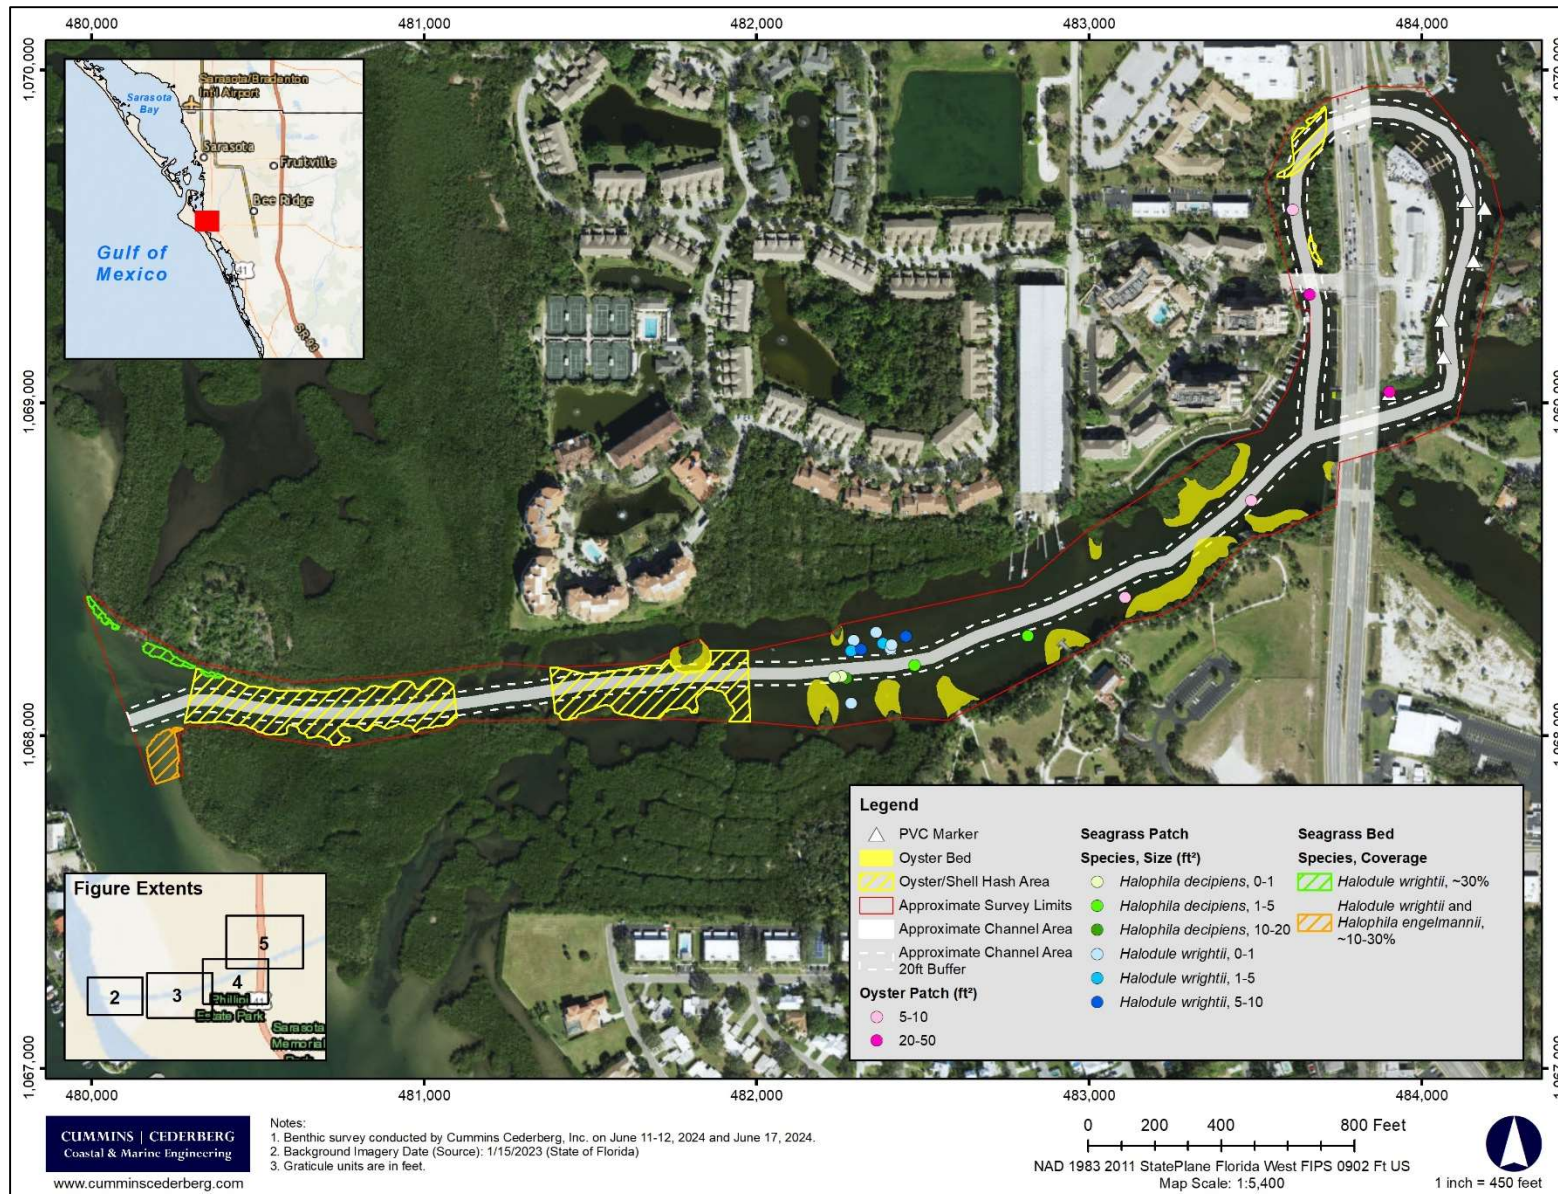
Figure 2. Basemap of documented resources. See Attachment B for zoomed in Figure Extents.

The Creek within the survey extents supports minimal oyster and seagrass habitat. Three species of seagrass were observed: *H. wrightii*, *H. engelmannii*, and *H. decipiens*. Seagrass was present in intermittent, small patches within a section of the survey area, except for at the mouth of the Creek, where approximately 30% coverage beds were present. Oyster habitat was primarily loose and scattered shell hash, with very few living oysters.

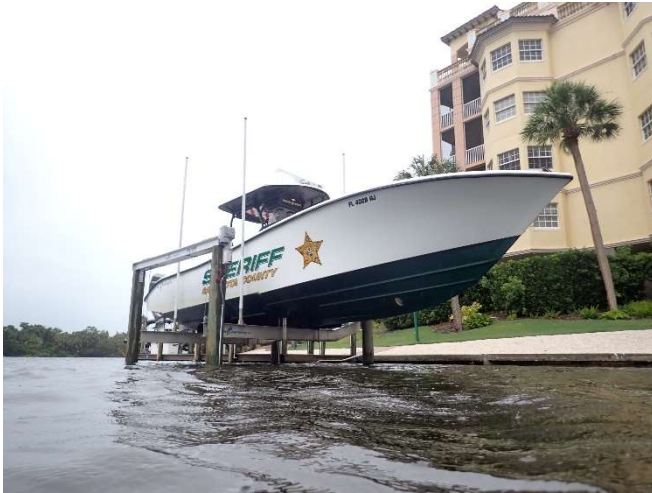
Photo 0-1. Sarasota County sheriff vessel docked at Phillippi Landings.

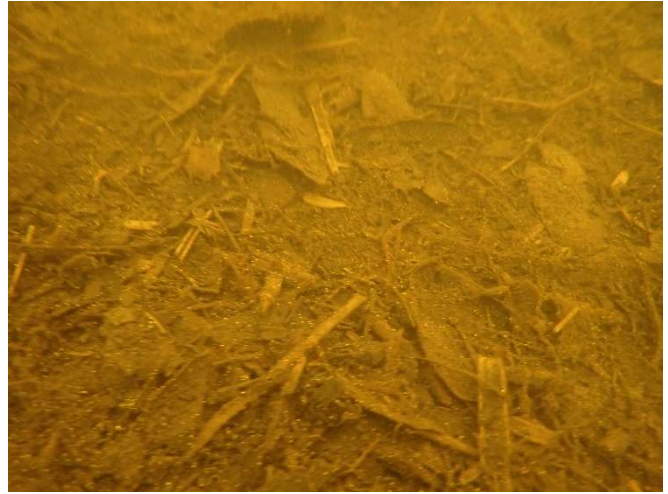
The substrate observed within the survey area generally consisted of silt and muck with detritus material (**Photos A-2** and **A-3**) on the eastern extents of the survey area and a sandier silt towards the mouth of the Creek with occasional vegetative debris. A hydrogen sulfide odor was present during the survey when the sediment was disturbed, especially upstream where the benthic community was generally devoid of resources.

Photo 0-2. Detritus material along the Creek bottom.

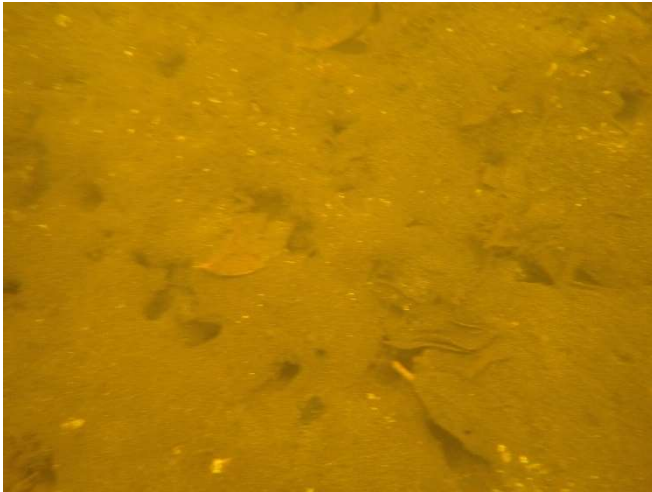
Photo 0-3. Silty muck substrate with occasional detritus material.

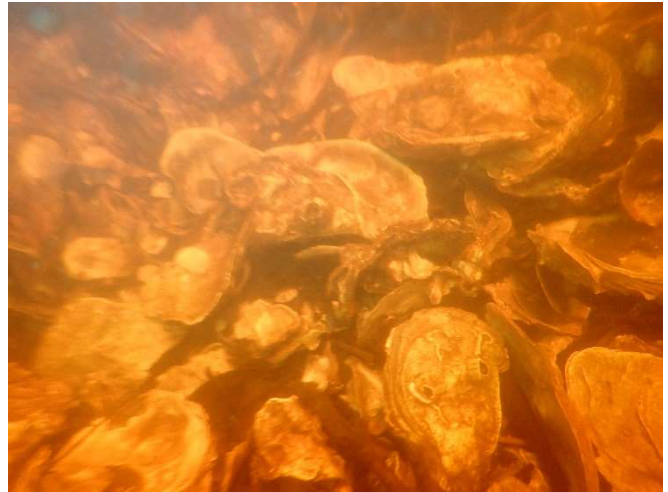
Photo 0-4. Example of loose, scattered oyster shell hash.

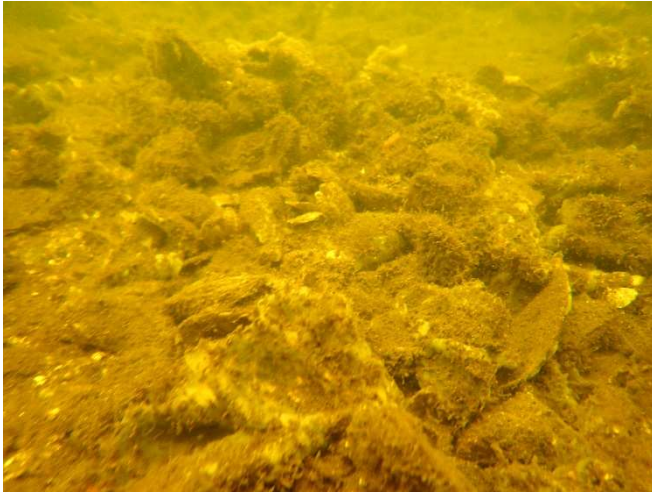
Photo 0-5. Example of an oyster bed where oyster shell was stabilized. Note sediment film on shells.

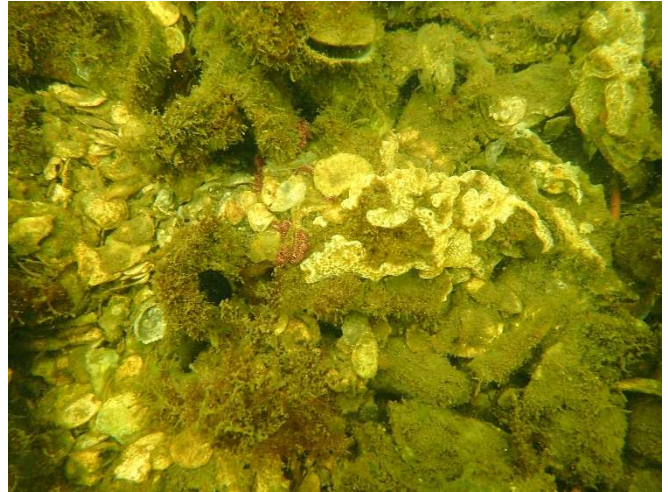
Oyster shells were located throughout the survey area, both in small clusters and standalone shells, as well as in large shell hash beds. The majority of oysters observed within the channel and buffer zone were deceased with less than 10% (estimated) of oysters living. Notably, the majority of oyster shell was covered in a thin layer of sediment. Oyster locations and extents are depicted on the basemap in **Figure 2**. Scattered, loose shell hash is indicated as “shell hash areas” (**Photo A-4**) whereas more stable and consolidated shell is indicated as “oyster beds” (**Photo A-5**). Sponge, tunicate, and turf algae overgrowth was common on the shell hash area closest to the Creek’s mouth (**Photos A-6** and **A-7**).

Photo 0-6. Oyster shell hash area closest to the Creek's mouth. Note sponge, tunicate, and turf algae overgrowth.

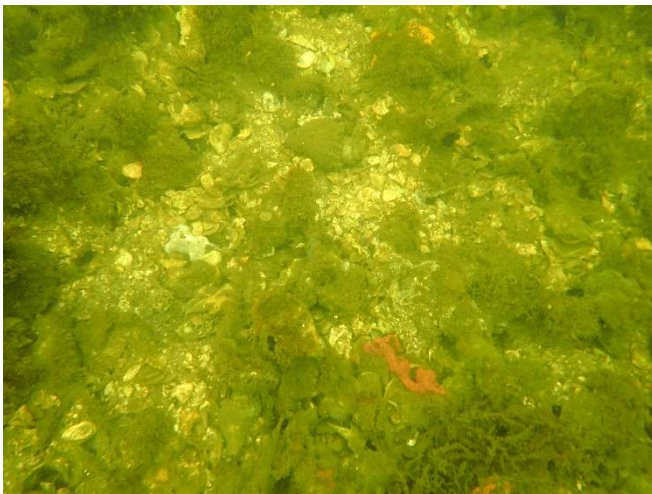
Photo 0-7. Scattered oyster shell hash area closest to the Creek's mouth. Note sponge, tunicate, and turf algae overgrowth.

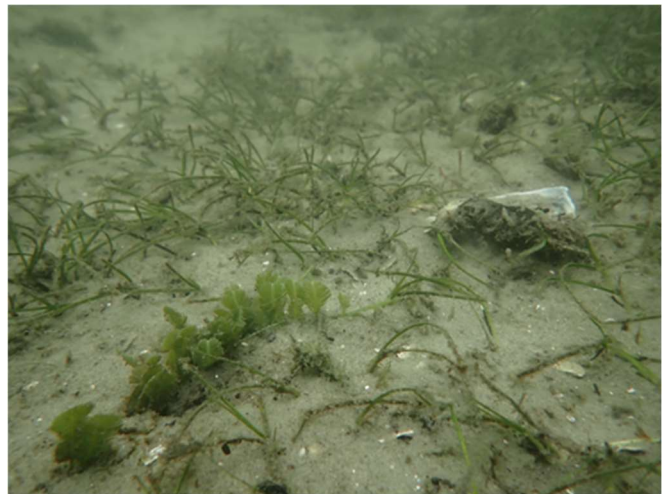
Seagrasses were observed to be growing near the mouth of the Creek as it feeds into the Intracoastal Waterway. Shoal grass (*Halodule wrightii*) was documented within the nearshore area along the north side with an overall coverage of approximately 30% (**Photo A-8**). On the south side of the mouth, an intermixed bed of *H. wrightii* and star grass (*Halophila engelmannii*) was documented with a varying coverage of approximately 10% to 30% (**Photo A-9**). Seagrasses within these beds extend beyond the survey area to the north and south. Small patches of macroalgae (*Caulerpa* spp.) were documented throughout both. Additional, discontinuous patches of seagrasses were observed and identified within the middle portion of the survey area, just northwest of Phillippi Estate Park, and included *H. wrightii* and paddle grass (*Halophila decipiens*) (**Photo A-10**). Locations of resources are depicted on the basemap in **Figure 2**. Zoomed in segments of this basemap are included as **Attachment B**. West Indian manatees (*Trichechus manatus*) were observed swimming upstream during the survey.

Photo 0-8. *H. wrightii* bed (~30% coverage) along the north shoreline of the Creek's mouth with *C. Sertularioides*. Note short blade length.

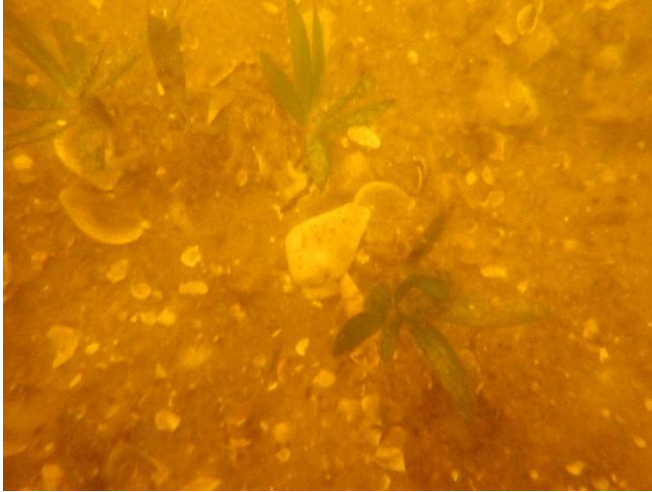
Photo 0-9. *H. engelmannii* observed at the south side of the Creek's mouth.

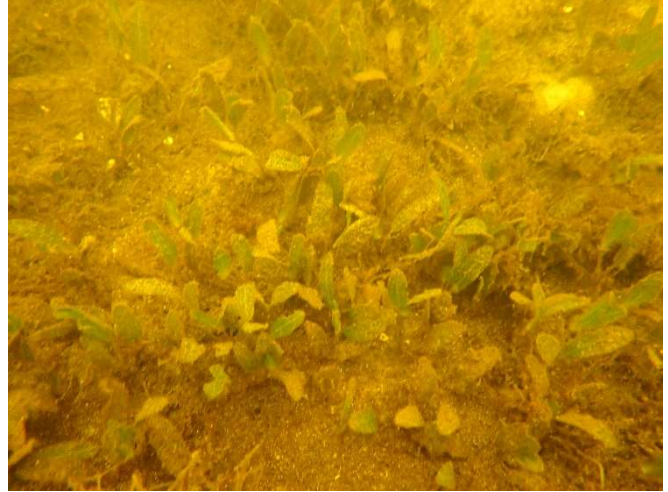
Photo 0-10. A patch of *H. decipiens* observed northwest of Phillippi Estate Park

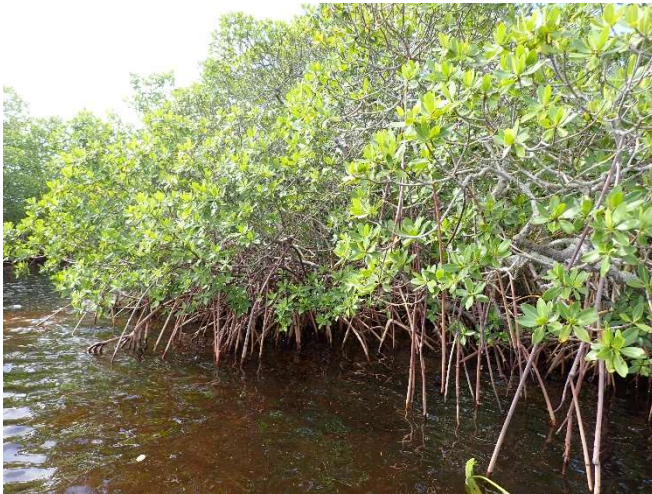
The shoreline along the survey area was primarily natural mangrove shoreline (**Photo A-11**) from the mouth of the Creek to the eastern extent of the survey area where the shoreline transitioned to seawall stabilization and occasional docking facilities to accommodate upland development. No other marine resources of significance were documented. Typical aids to navigation (ATONs) or channel markers demarcate the channel limits east of the US-41 bridge. West of the US-41 bridge, PVC pipes appear to have been installed to delineate the channel.

Photo 0-11. Example natural shoreline vegetated with *R. mangle*.
